Dynamic Tests Of Short Sections Of Corrugated Metal Beam
Guardrail

January 1969

State of California
Department of Public Works
Division of Highways
Materials and Research Department

DYNAMIC TESTS OF SHORT SECTIONS OF
CORRUGATED METAL BEAM GUARDRAIL

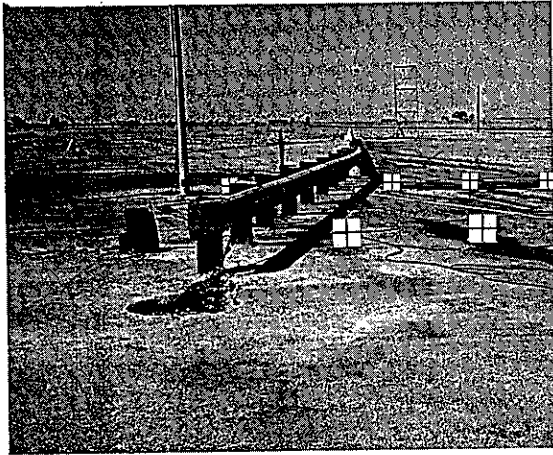
Figure 11

the first 12 ft from the bridge rail end so the remainder of the barrier could be placed on a straight line with a 4-ft end offset from a projection of the bridge rail line (Figure 11). The downstream end of the guardrail beam was secured to a nonreinforced concrete simulated bridge rail with two 1-in. dia high strength bolts through 1-1/8-in. dia holes bored through the concrete. An 8- by 12- by 18-in. wood block was placed between the beam and the concrete (Figure 12).

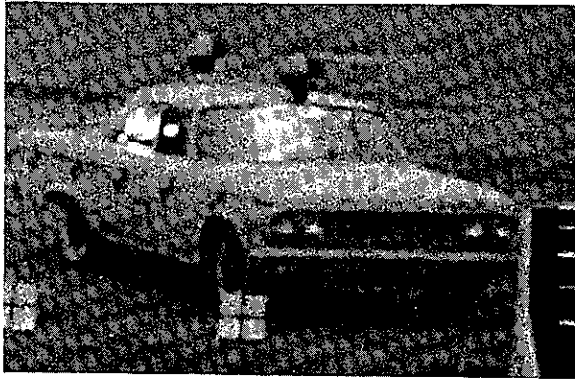
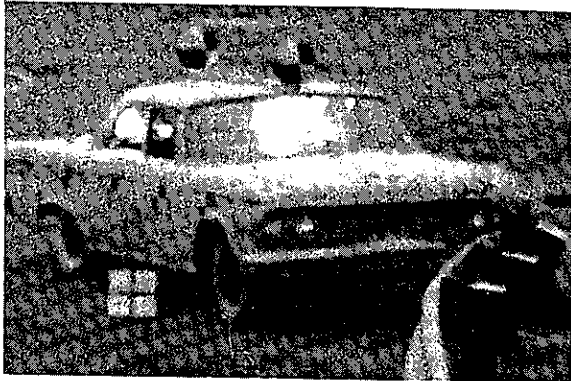
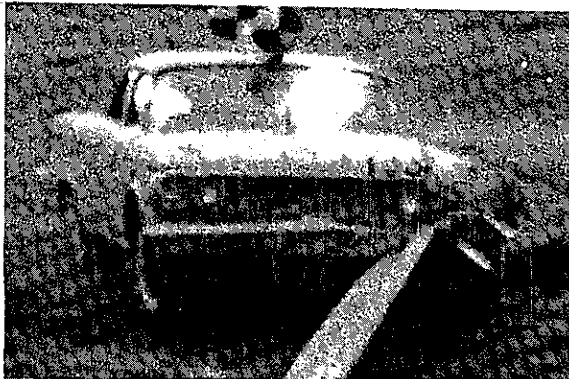
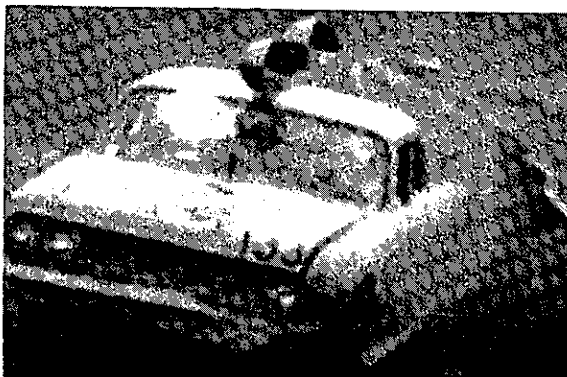
PLATE A TEST 133

2. Although Test 133 demonstrated the structural adequacy of the "Texas Twist" design in providing effective anchorage for short sections of guardrail, Test 134 showed that a hazardous condition exists when vehicle impact occurs at the upstream sloping beam end anchorage.

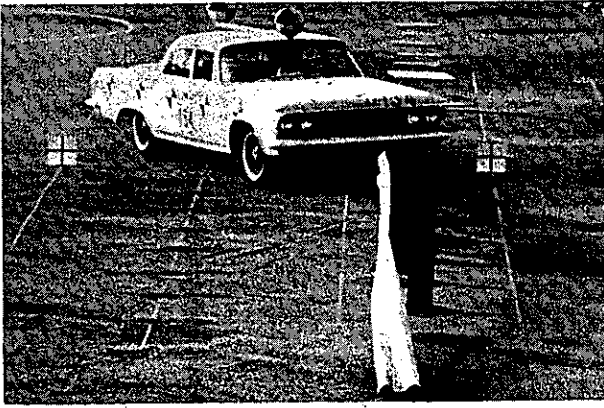
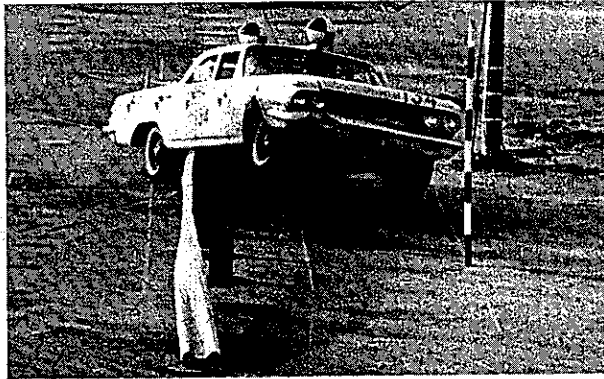
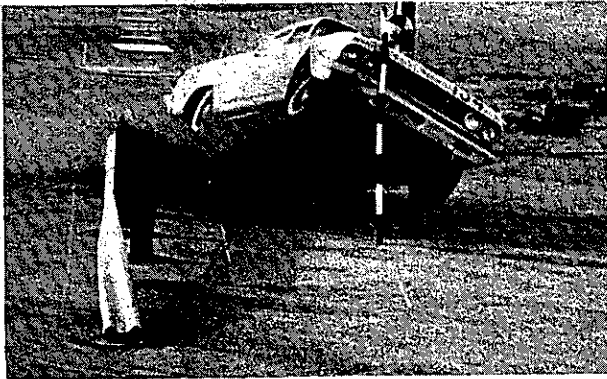
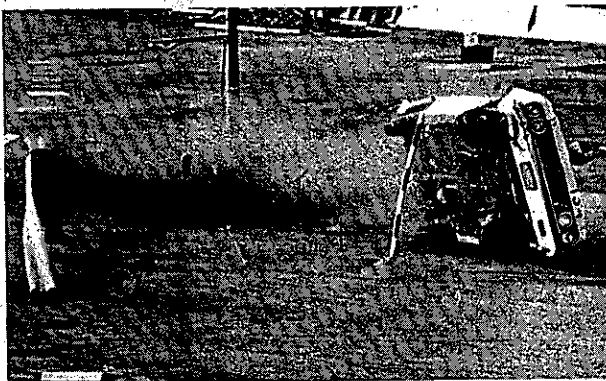
PLATE B TEST 134

Although Test 133 demonstrated that the "Texas Twist" anchorage system was structurally adequate, it was felt that the geometric characteristic of the sloping beam end anchorages presented a potentially hazardous condition. The sloping beam could form a ramp upon which an impacting vehicle might climb and vault the barrier. Therefore, in Test 134 (installation identical to Test 133), the point of impact was shifted upstream with the vehicle impacting the barrier within the sloping beam portion, 4.9-ft from the concrete end anchor, at 63 mph/24 deg. The beam at this point was too low to effectively resist the vertical downward force of the impacting left front wheel which deflected the beam down, permitting the front wheel to ride up and over the beam. This reaction of the beam imparted a rolling moment to the vehicle which completely overturned as it vaulted the barrier. The vehicle came to rest 180 ft beyond impact in a regained upright position (see Plate B).

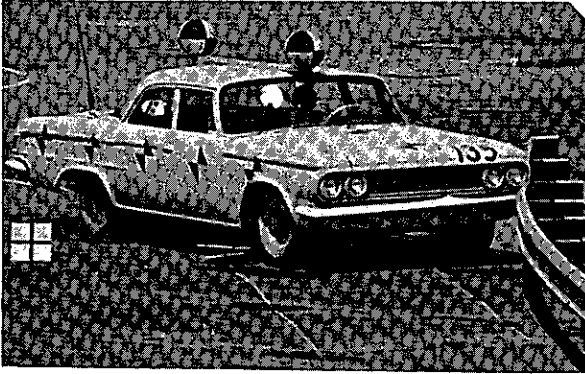
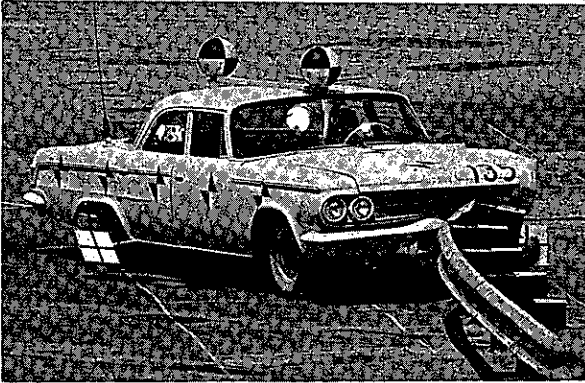
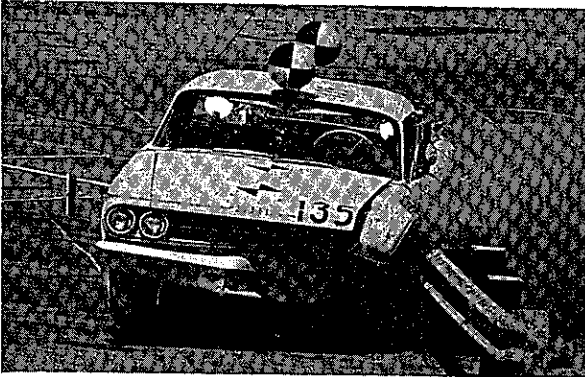
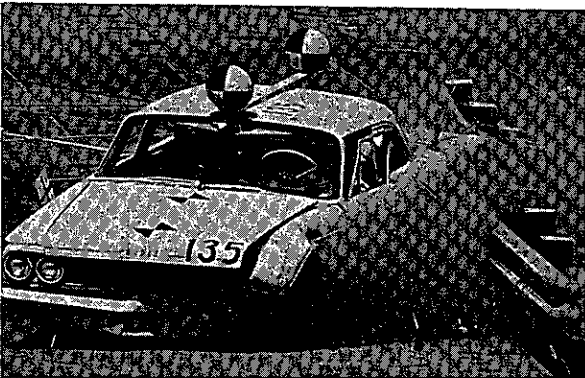
PLATE C TEST 135

4. Test 135 indicated that a parabolic layout line for an anchored guardrail section will increase the likelihood of pocketing over that of a straight section between the same two end anchor points under similar conditions of impact.

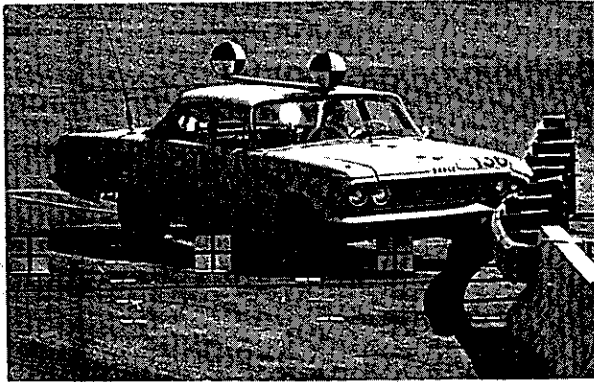
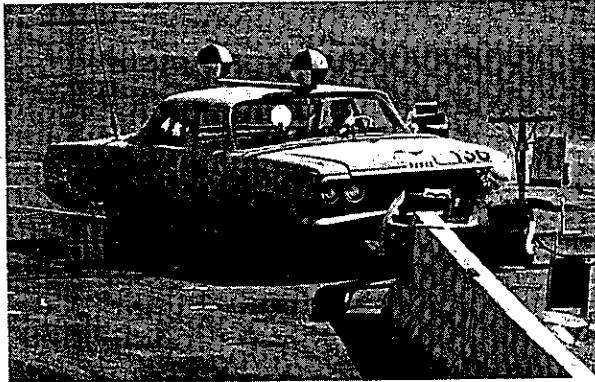
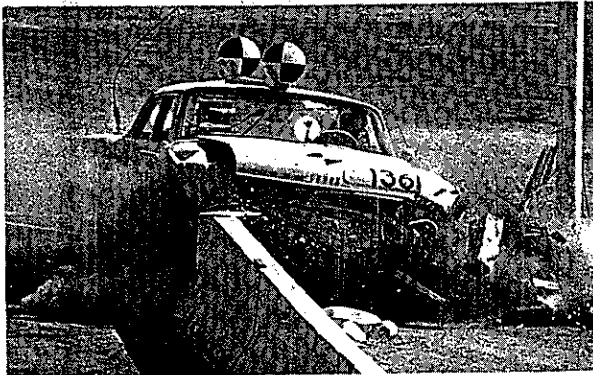
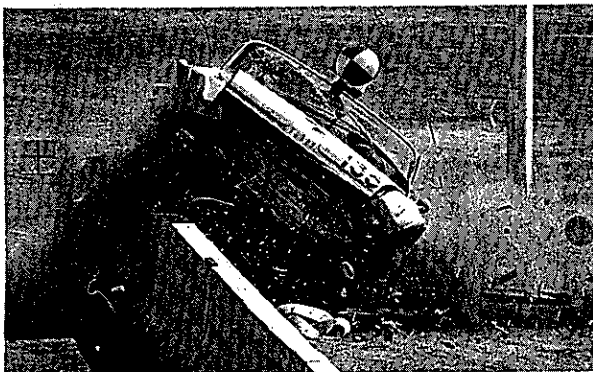
PLATE D TEST 136

The test vehicle impacted the guardrail at 60 mph/33 deg 18 ft upstream of the end of the simulated bridge rail, pocketing the beam severely (see Figure 13 and Plate D). As the vehicle was being redirected, the nonreinforced concrete bridge rail failed through the connection holes, allowing the beam to pull free and permitting the vehicle to penetrate the barrier. As the vehicle progressed through impact, the right front wheel struck the end of the concrete rail throwing the vehicle into a violent roll-over. The vehicle came to rest 45 ft beyond initial impact in an upright position. Two sections of beam were damaged, three timber posts broken off, and four block-out blocks shattered. The vehicle sustained major front, side, and top damage and was considered a total loss (Figure 14).

Analysis of the data film indicated that even if the concrete bridge rail connection had not failed, beam deflection and pocketing had already occurred to such an

extent that the vehicle would not have been redirected sufficiently to avoid an end-on collision into the concrete rail.

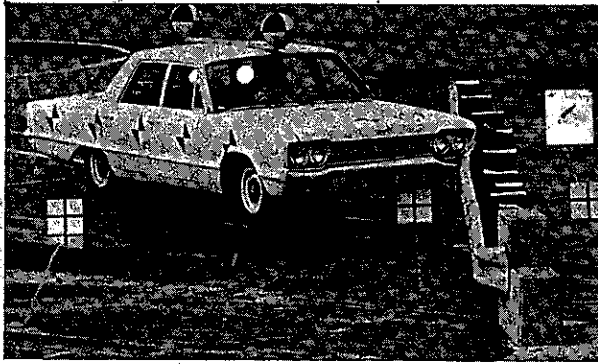
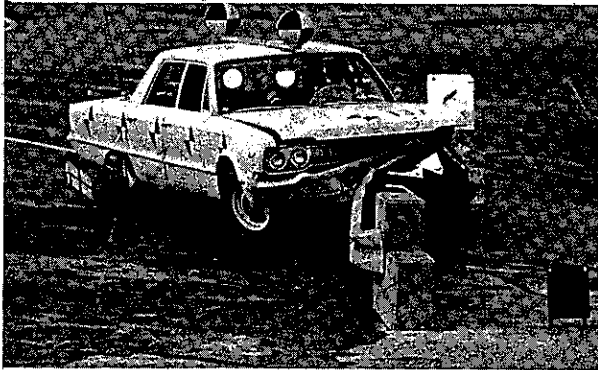
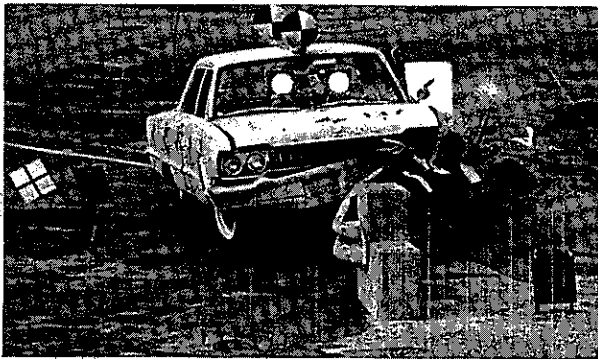
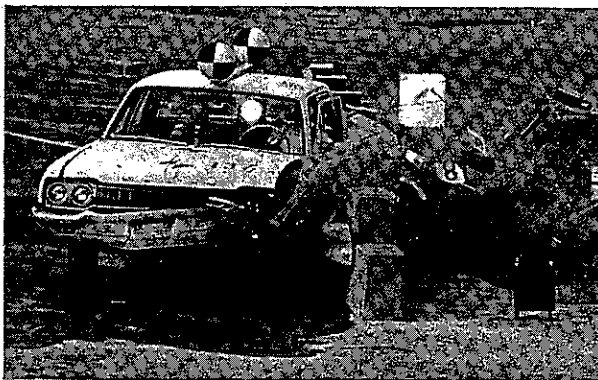
PLATE E TEST 137

The vehicle impacted near the center of the guardrail section at 61 mph/27 deg and remained in contact with the

barrier for approximately 22 ft before being effectively redirected at an exit angle of 16 deg (see Plate E).

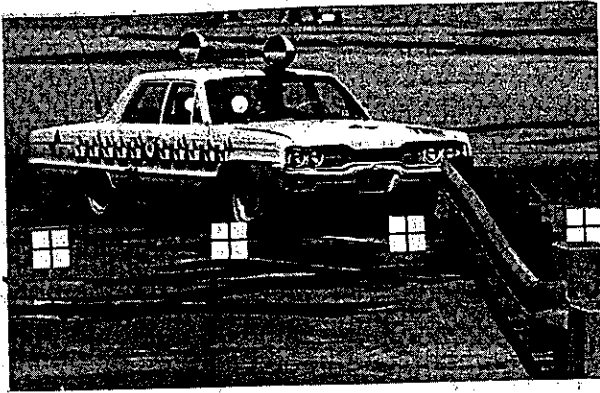
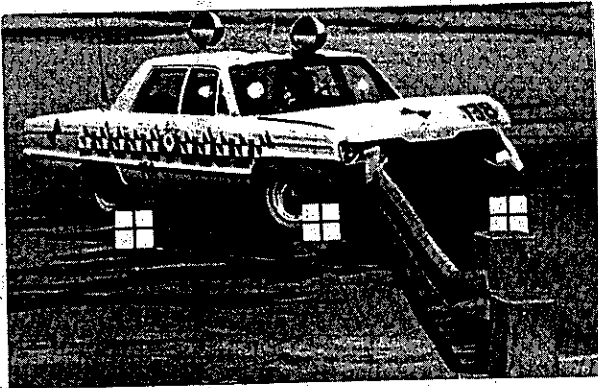
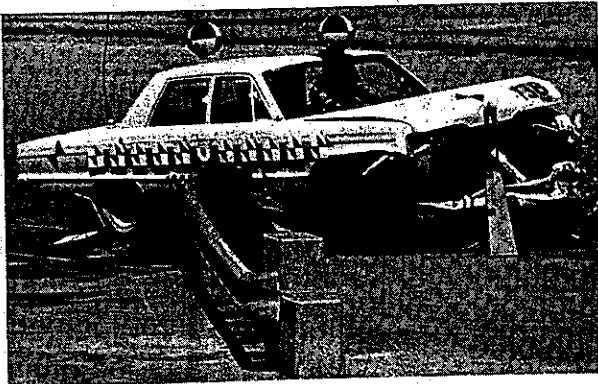
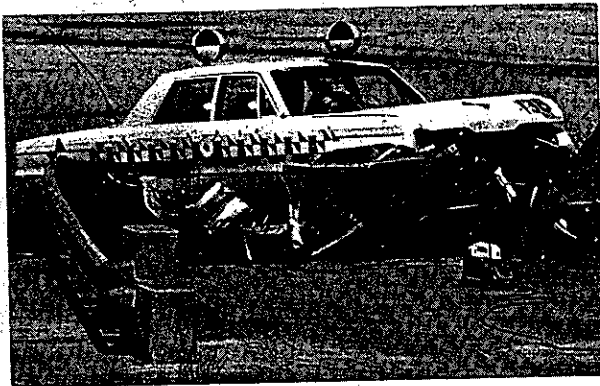
PLATE F TEST 138

5. Test 138 indicated that the effect of a high speed oblique angle impact into the upstream end of a cable anchored guardrail, although severe, is less hazardous than similar impact into sloping beam guardrail end anchorage systems. This would be particularly true for sections of guardrail which are flared away from the traveled way, thereby minimizing the chances of head-on end impact.

spearing" into the end of a flared guardrail section are not great, the upstream cable anchorage system does present a potential hazard. In Test 138 (installation identical to Test 137) the vehicle impacted the guardrail at 61 mph/25 deg into the end terminal section, upstream of the cable-to-beam connection. The beam bent, the left front wheel rode up and over the cable anchor eye-bolt and the vehicle, straddling the cable, impacted post No. 1. The cable failed in tension as the vehicle, pushing the beam ahead of it, penetrated the barrier (see Plate F and Figure 19).
